# CORROSION ISSUES

- Phil Sadler, Senior Utilities Safety Engineer
- Noel Travis, Utilities Safety Engineer

**SISSONVILLE, W. Va. December 11, 2012, 20-inch natural gas transmission pipeline running west to east, perpendicular to Interstate 77, ruptured about 112 feet west of Interstate 77**

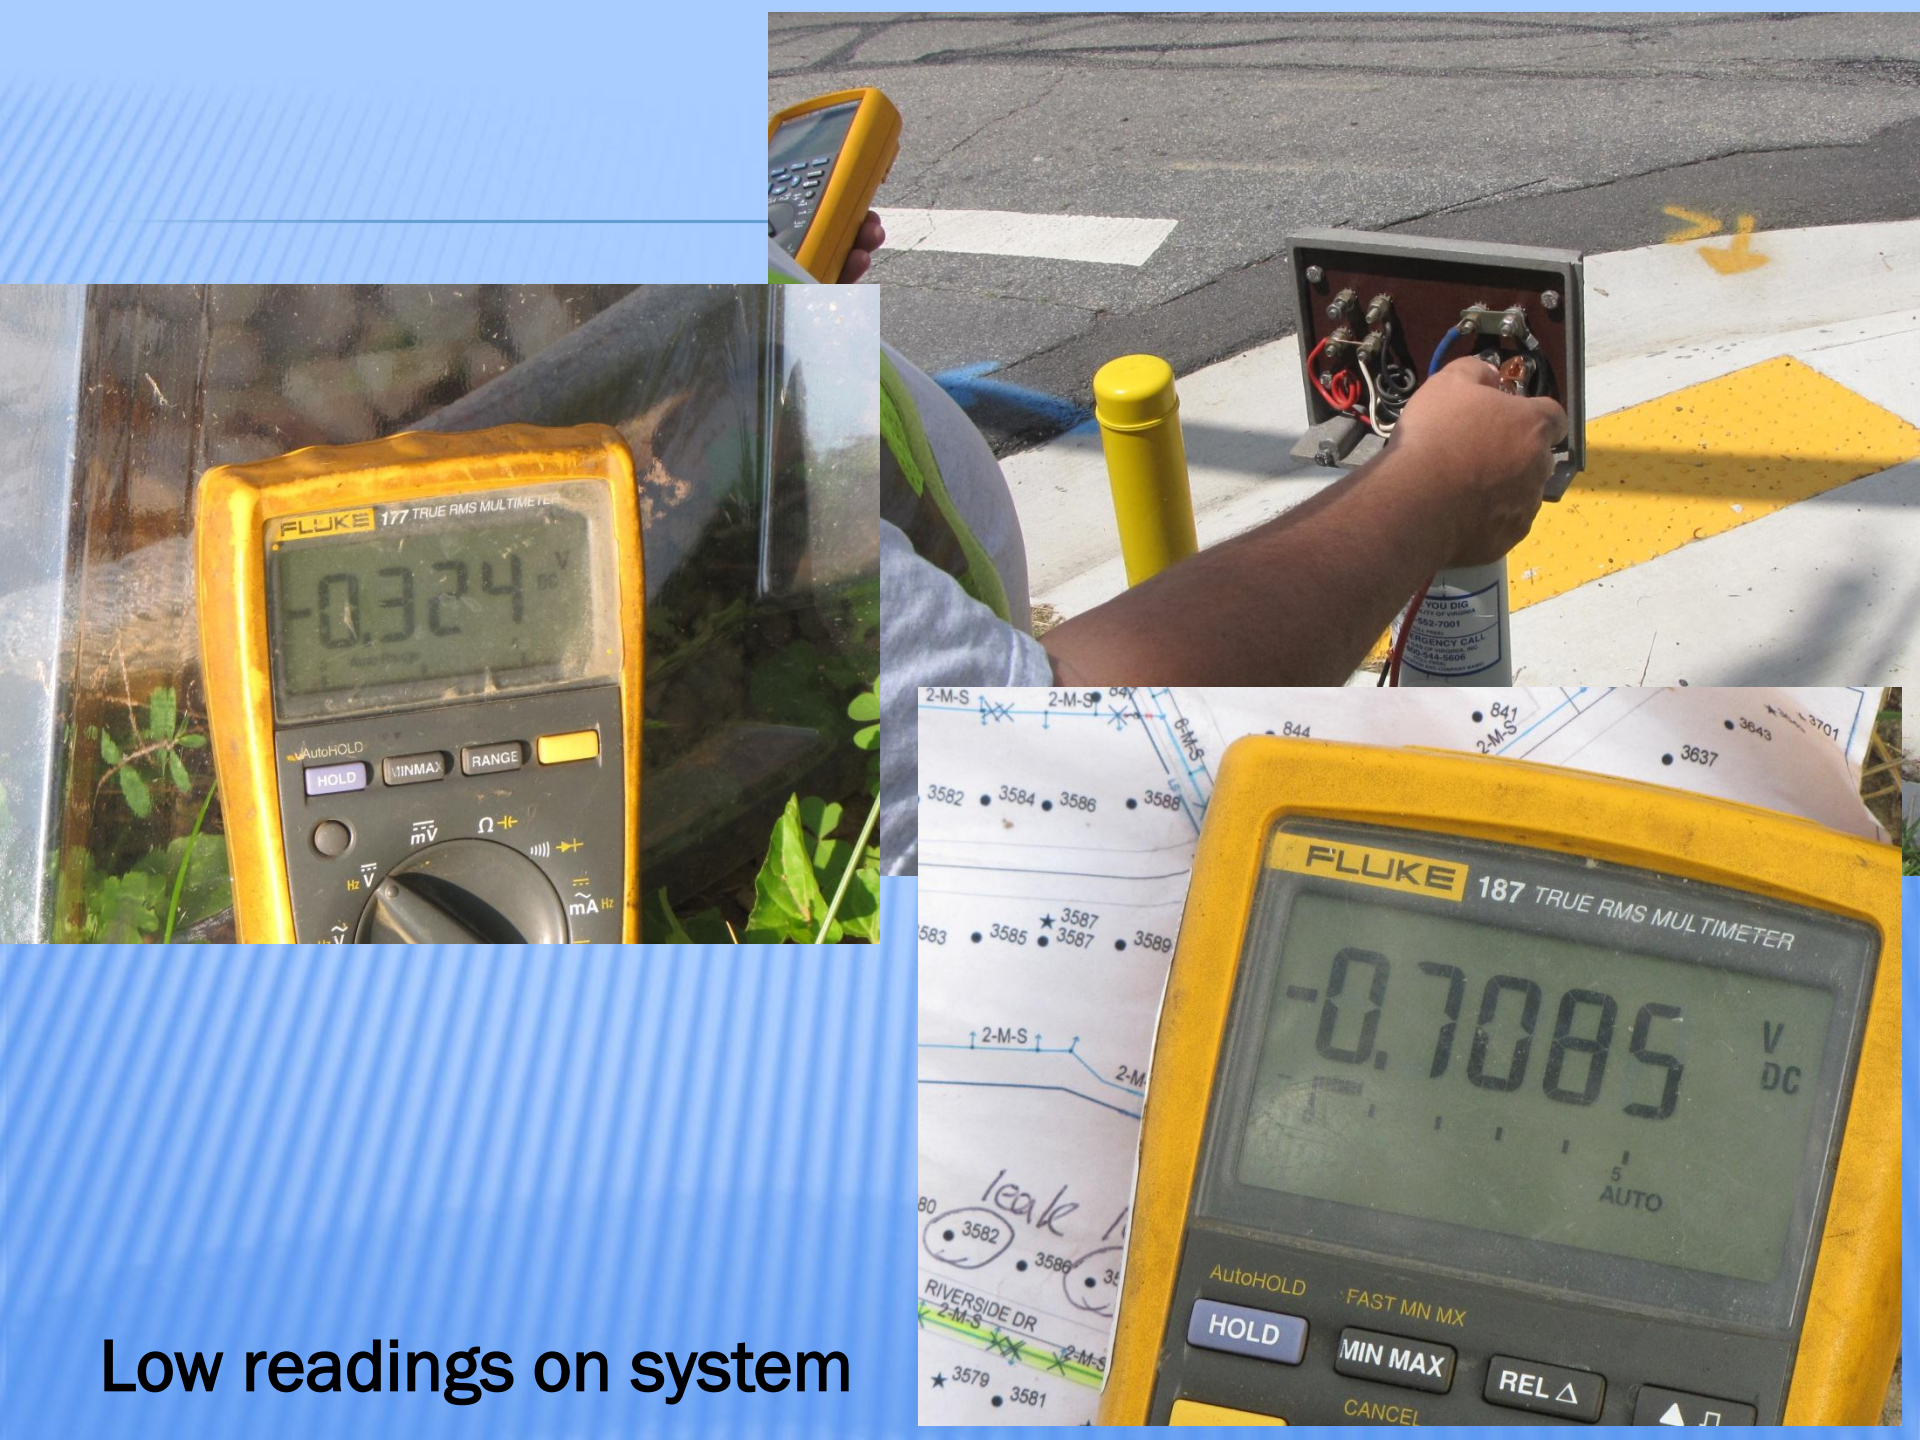
Low readings on system

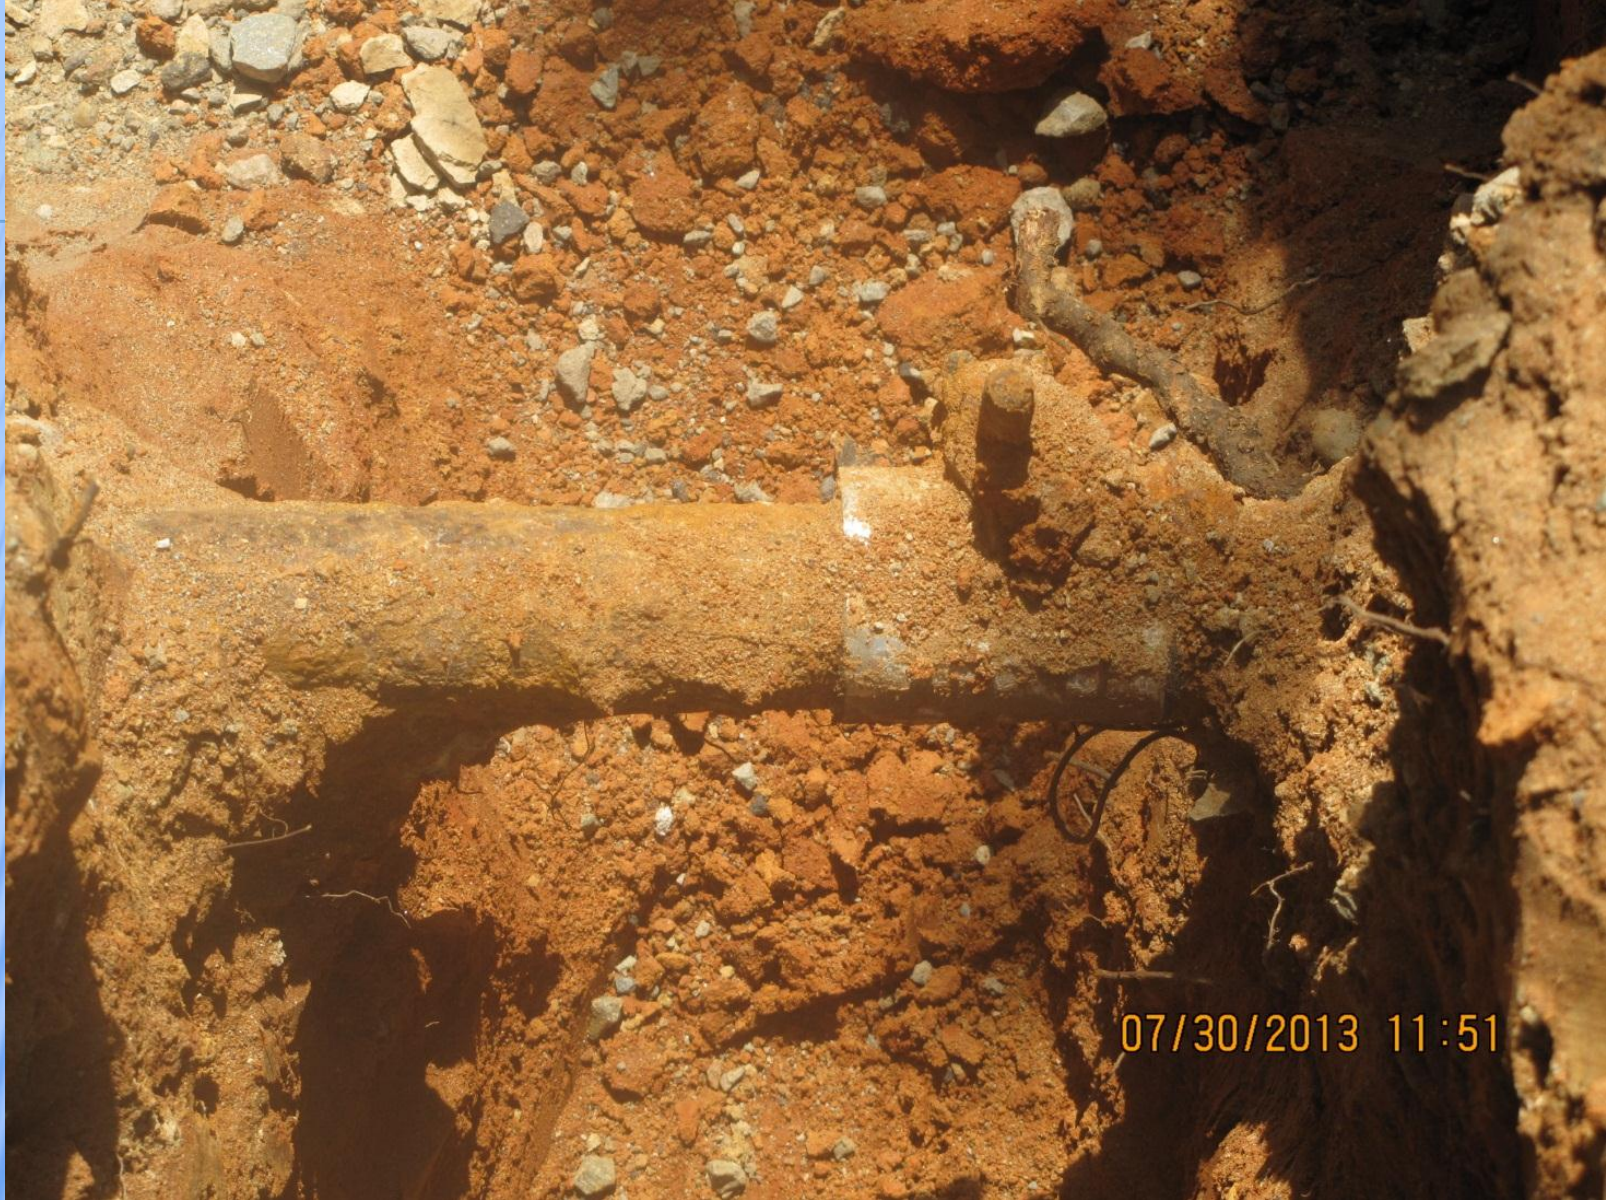
**Not taking readings when doing repairs - Areas of active corrosion no actions taken**

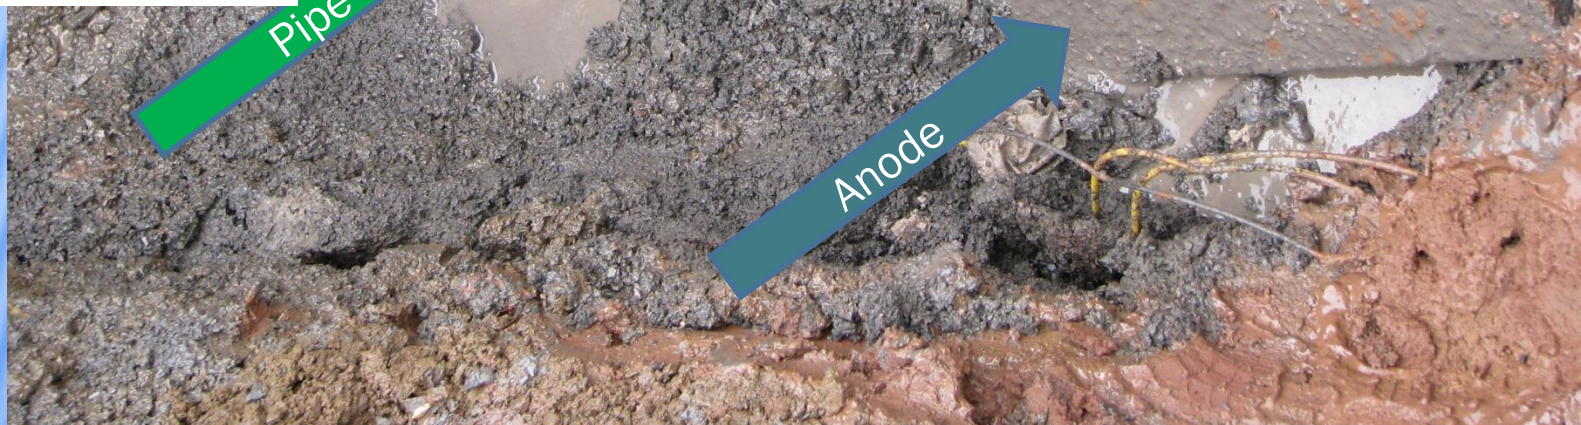
**Anodes not installed properly**

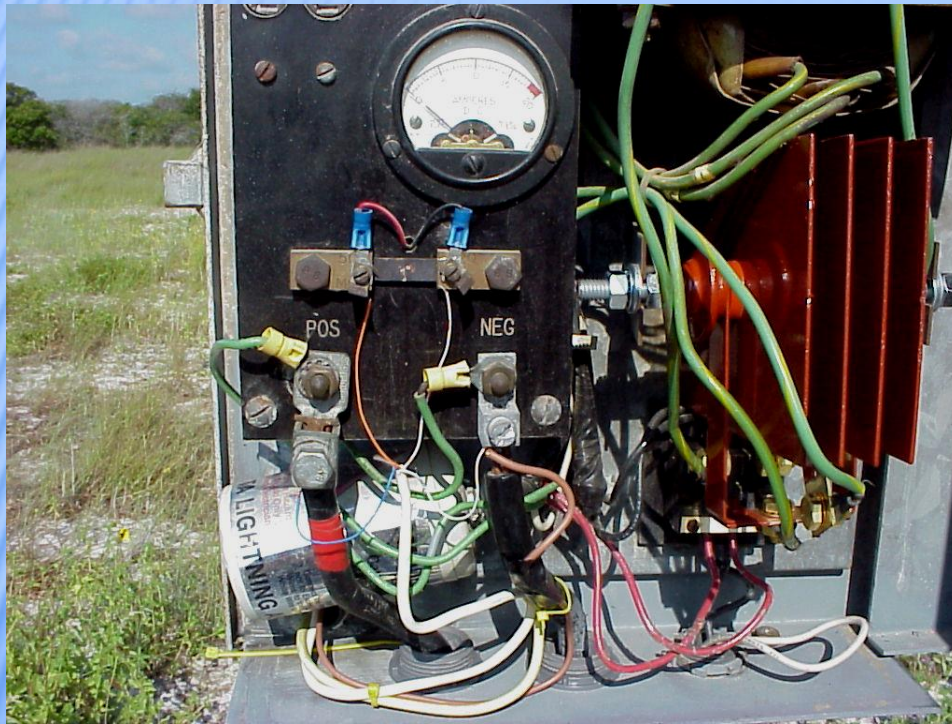
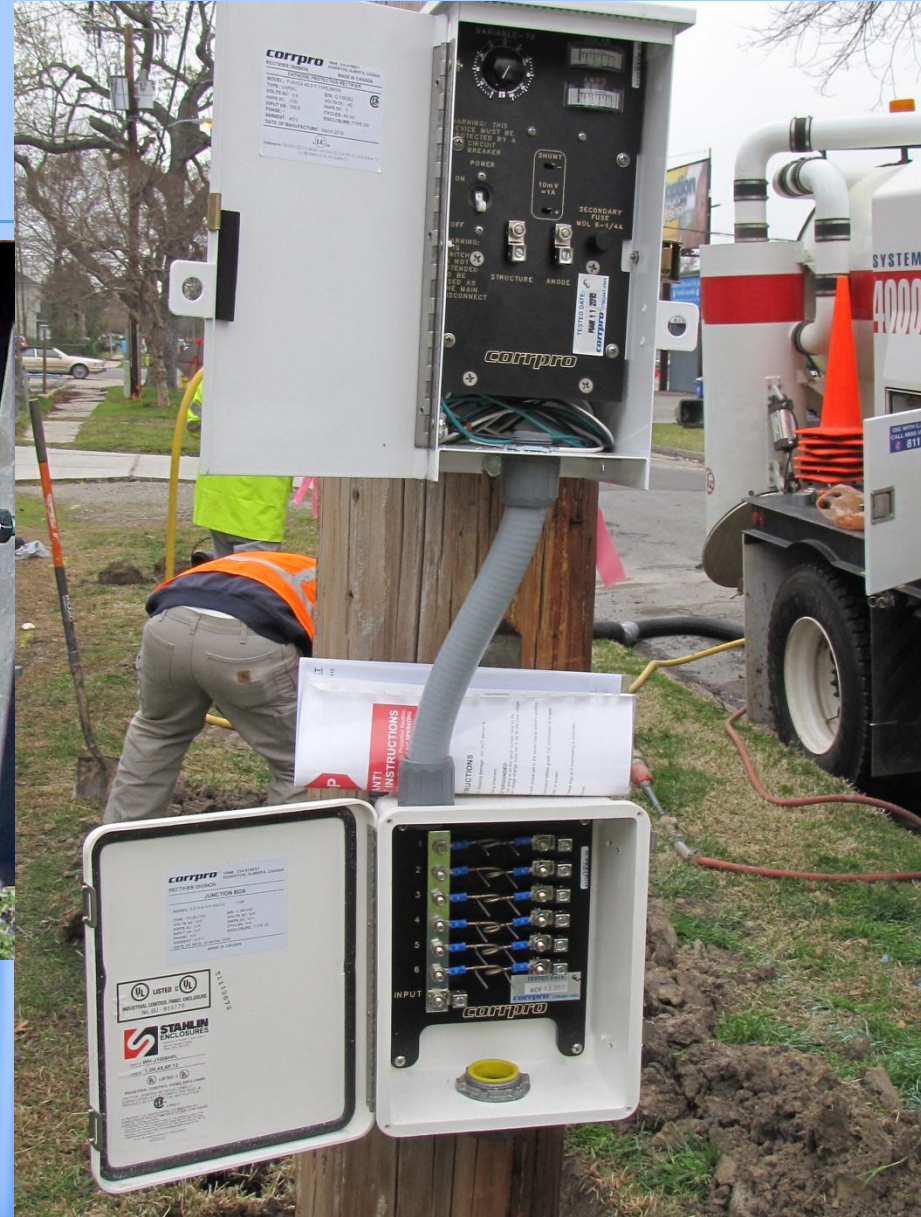
§192.465 (b)

Failure to inspect each cathodic protection rectifier impressed current power source six times each calendar year, but with intervals not exceeding 2 1/2 months, to insure that it is operating properly.

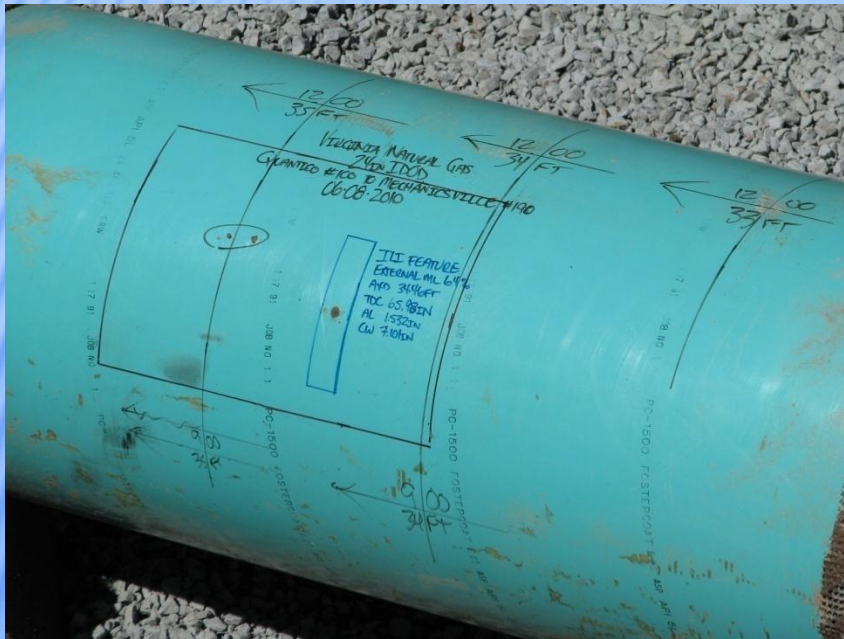
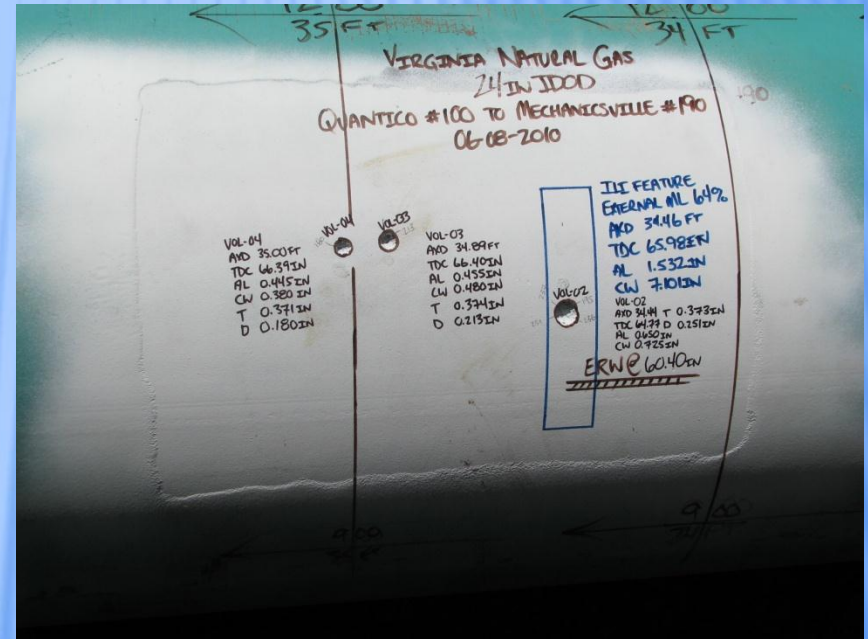
- Corrosion Product
- MFL Tool Results
  - Depth Under Call?
